Hungarian University of Agriculture and Life Sciences

Fostering Resilient Cities through Urban Green Infrastructure: A Complex Evaluation Method for Urban Green Morphology on a Budapest Case Study Site

GABRIEL SILVA DANTAS

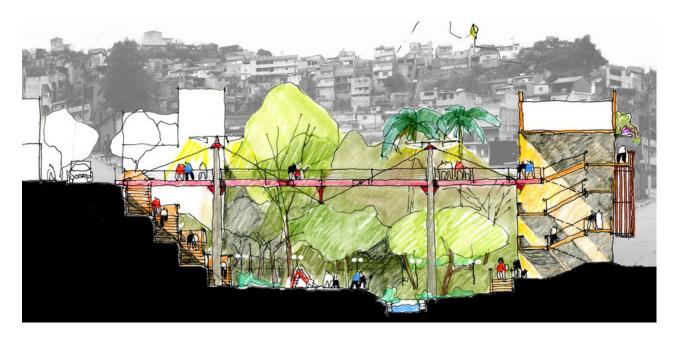
Figure 9: Sketch of the pedestrian overpass designed for Parque Novo Santo Amaro V. Source: Vigliecca & Associados, 2017

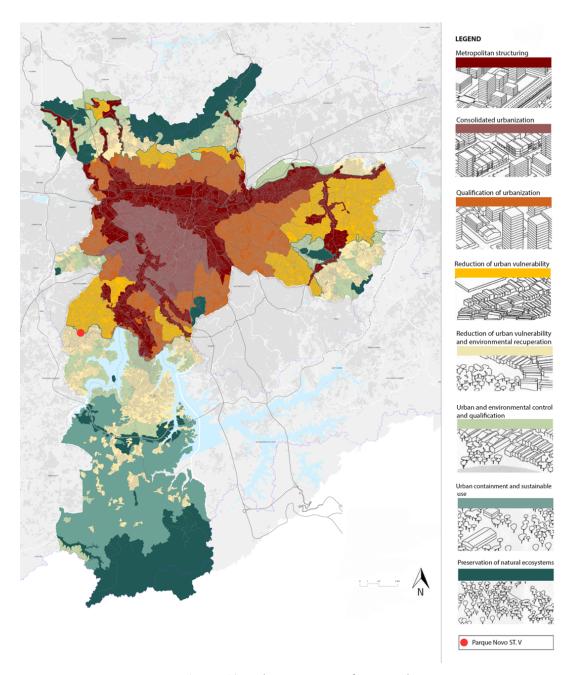
Figure 10: Urban structure of São Paulo. Source: São Paulo Development Plan, 2014 – edited by author.

Despite this heterogeneous scenario, most of the formally planned zones with consolidated urbanization and the metropolitan structuring zones are located in the city's center, in its northwest region. Those zones are where the main connection axes, dense public transport network, and the most extensive commerce and service hubs are found consecutively. The poorest neighborhoods, described in the São Paulo Urban Development Plan as "areas of urban vulnerability," are concentrated in the eastern and southern zones, where there is also greater concern about experiencing disorderly urban sprawl in environmentally protected areas (see Figure 3).

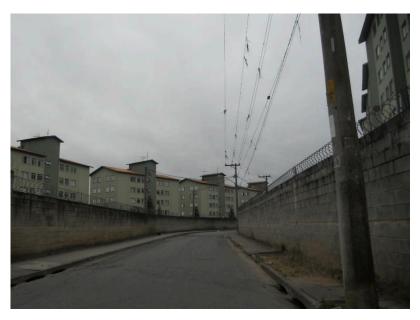
Figure 11: Urban landscape MCMV in housing estate area – São Paulo. Source: Google Maps

The MCMV residential program does not demand any analysis of the pre-existing fabric, causing difficulties in the city's mobility system. There are no requirements for green space networks (see Figure 4). For this reason, this type of urban solution has a low percentage of green spaces and permeable surfaces, which also overloads the rainwater infrastructure. The construction legislation of São Paulo also does not limit the minimum distance between buildings within the same plot, which significantly compromises the landscape quality in these areas (see Figure 5).

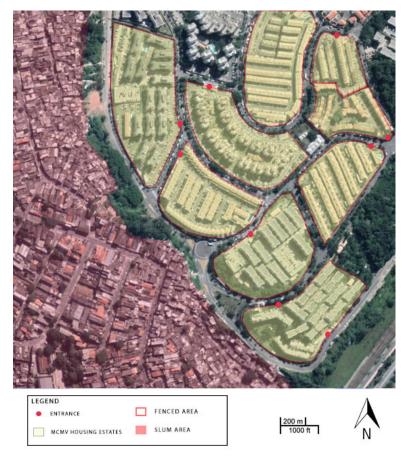
Figure 12: Comparison between favela occupation and MCMV housing developments. Source: by author

The demographic density of the São Paulo favelas was estimated, in 1987, at 446.2 people per hectare (Brazilian Institute of Geography and Statistics, 2014), a value that approximates the average found also in housing estates built through the MCMV program (200 - 400 p/ha) in the central areas. Despite the similarity, these urban configurations are entirely different structures.

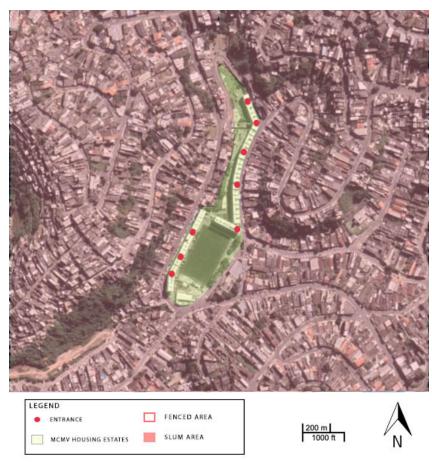
Figure 13: Parque Novo Santo Amaro V - implantation in urban context. Source: by author

This way, the Parque Novo Santo Amaro V project, located in the south of São Paulo, proposed by Vigliecca & Associados, is a good example of social housing that has managed to overcome the barriers defined by extremely restrictive legislation and the low cost construction technics, in order to achieve a better urban environment and landscape design (see Figure 6). In this case, the green system in this project is also wholly public, maintained by the state.

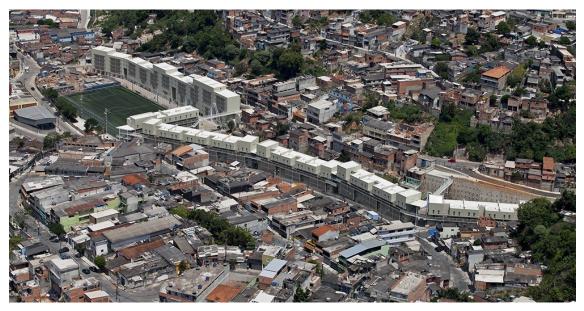
Figure 8: Aerial image – urban insertion. Source: Vigliecca & Associados, 2017

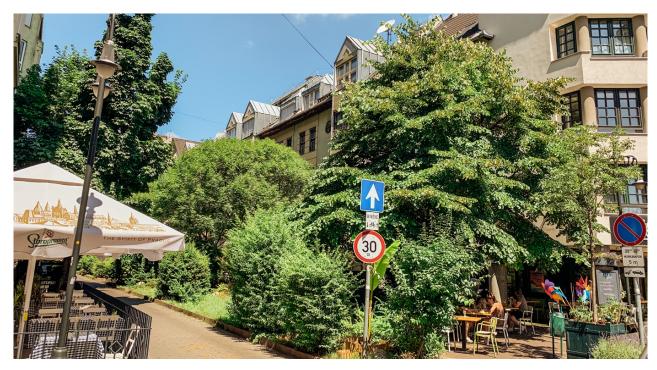
Figure 9: Tompa Street at Ferencváros District. Source: by author

According to Ribeiro and Gonçalves (2019), the concept of urban resilience is related to the capacity of an urban territory to adapt to possible disruptions, perpetuating urban dynamics and existing physical conditions that characterize a place and its landscape. In addition, it enables the emergence of new socio-spatial expressions. The study area analyzed at Ferencváros had its urban renewal process carried out through uncertain periods of significant political and social changes (Figure 9).

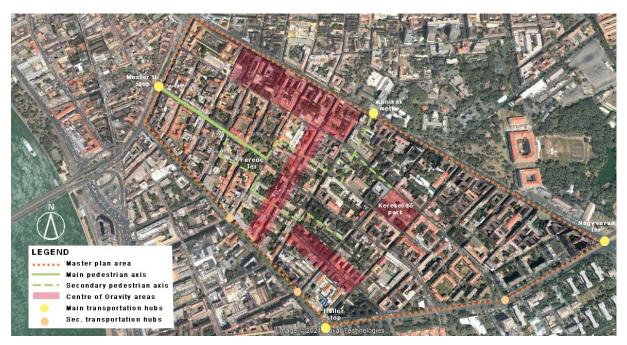
Figure 12: Gravity Centers articulated by green pedestrian axis Source: by author

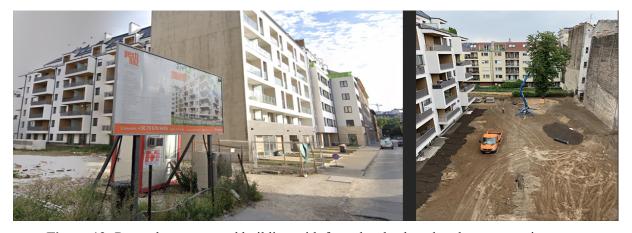
Figure 13: Recently constructed building with frontal setback and under construction common courtyard accessible directly from public street.

Regarding the physical elements used as tools for territorial transformation, four artifices outstand: integration and consolidation of community courtyards, creation of green alleys for pedestrians, building's frontal setbacks, and reformulation of green public squares system. Those elements were articulated to provide the emergence of complex green infrastructure in the area. Nevertheless, the urban design was conceived to avoid severe disturbances in the typological characteristics, respecting modularity, ratio distribution, scale, and even materiality aspects (Figure 13).

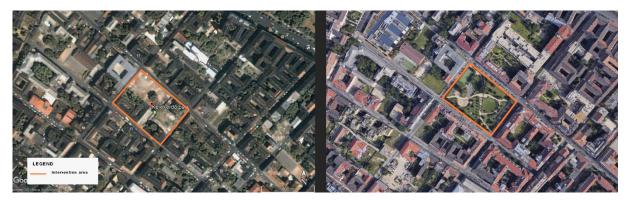
Figure 14: Remaining urban block before and after the demolition of residential buildings for the implementation of an urban park Ferencváros.

In line with that notion, the reconfiguration of the historic courtyards and the entire demolition of some poorly conservated buildings, despite being antagonistic to the movement of typological perpetuation, allowed the revival of the area's configuration (Figure 14). As a result of this process, it is possible to highlight the improvement in public health performance, equal access to leisure, strengthening of social relations, protection of biodiversity, and increase in local economic activities (Pauleit et al., 2019).

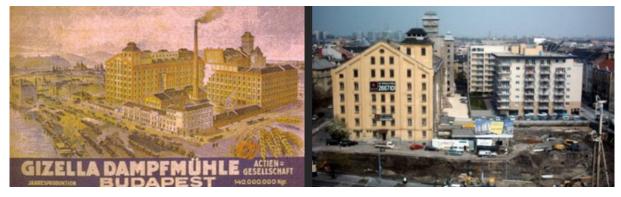
Figure 15: Resilient urban elements: prior industrial building converted into high-end housing – Ferencváros

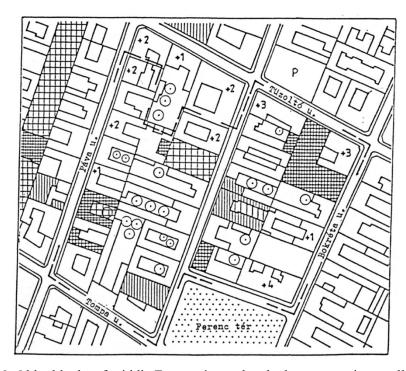
Figure 16: Older blocks of middle Ferencváros - hatched areas as prior small industries Source:

In general, each building was equipped with its courtyard, in many cases, dimly lit, lacking green elements, and in poor maintenance conditions. The urban reconstruction project called for the demolition of some wings of traditional buildings, or in some cases, their complete demolition, to generate enough space to implement a shared green infrastructure.

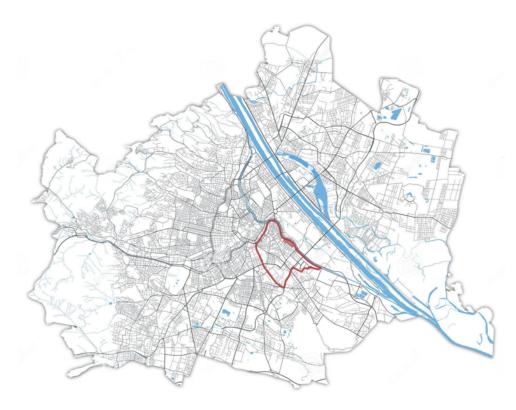
Figure 21: The Landstrasse District in Vienna is outlined in red on the map. It comprises a transitional character, reaching from central locations and neighboring the city's first District to less dense southern

areas when it approaches the outskirts. The highlighted red patch denotes the focus of the Space Syntax research site, which was, until recently, an urban void previously occupied by local industries.

Landstrasse, the Third District of Vienna, has witnessed intense restructuring comparable to those in Budapest's IX District. This district is also characterized by a diverse pattern of urban utilization, with a predominant middle-class residential fabric interspersed with urban voids. Historically, these voids served as sites for small-scale industries and orchards, reflecting a rich industrial past. The recent changes have been focused on redefining these spaces, transitioning them into integrated parts of the urban context while preserving the unique historical identity of the area. This thoughtful approach to urban renewal has successfully blended contemporary living with the district's storied heritage (see Figure 21).

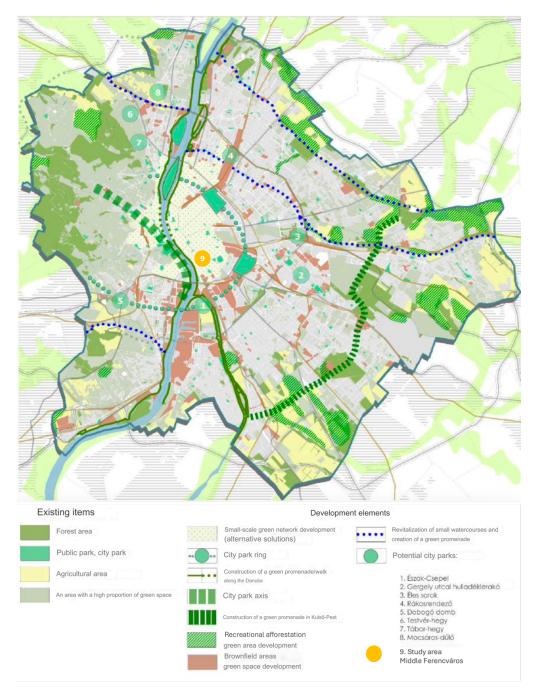
Figure 22: the Budapest 2030 Concept - Development of Green Infrastructure Source: Budapest Municipality, 2017

The Middle-Ferencváros area is demarcated as a zone for "Small Scale Green Network Development (Alternative Solutions)" within the Budapest 2030 Concept, highlighting its strategic role in the broader green infrastructure framework of the city (Budapest Municipality, 2017). This designation emphasizes the district's potential for innovative green solutions to address urban sustainability challenges in a densely built environment (figure 22). The emphasis on small-scale green network development articulates the district's historical context and spatial constraints, allowing for targeted interventions exploring the traditional courtyards and the edges of the urban blocks.

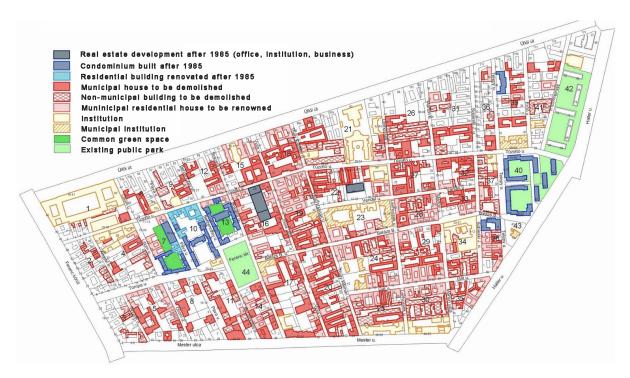
Figure 23: Land use analysis of middle Ferencváros, 1990 (Municipal data)

Some buildings were selected for total or partial demolition as part of the territorial and landscape integration strategy. Most of them were in municipal ownership, which facilitated the management of the renovation action. Other municipally owned buildings were determined for renovation. A percentage of the new areas obtained with these measurements, in articulation with the voids of the former industrial plots, was designated to establish green spaces (figure 23).

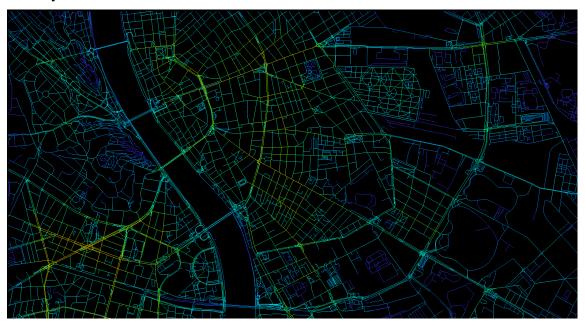
Figure 24: Global integration analysis of Budapest's southern region network (2020) performed on DephtmapX. Source: by author

In order to interpret the results obtained in the DepthmapX, it must be considered that this software utilizes a visual color scale to denote the levels calculated in each of the analyzed segments. In the case of this study, the warmer colors indicate a greater degree of integration and connectivity on the axis.

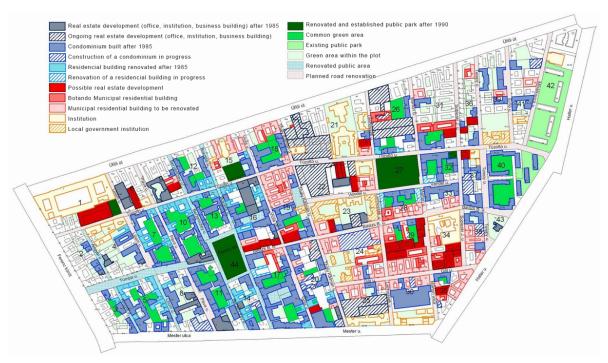
Figure 25: Land use analysis of middle Ferencváros, 2007– increased public or semi-public green areas. Source: Municipal data

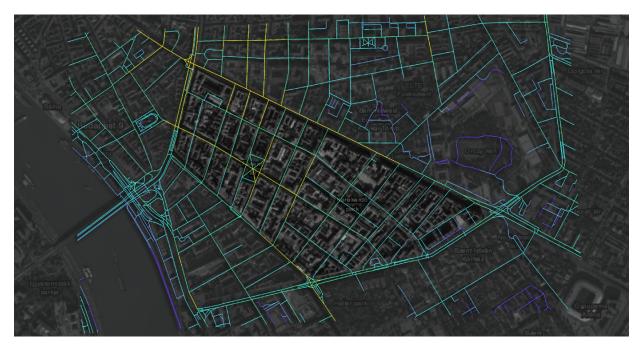
Figure 26: Global integration analysis of middle Ferencváros (1990) performd on DephtmapX. Source:by author

As input for the first phase of the investigation, the road network was used from the middle of Ferenceváros region dating from 1990. At that time, the road network and the pedestrian paths coincided in almost the entire territory. Thus, it is possible to notice that the axes (primary spatial components) allowed restricted territorial integration due to the morphological configuration of the area, limiting movement to the edges of urban blocks - a typical feature of historic urban settings. As an outcome, those conditions lead to a territory with lower levels of integration, symbolized on the map by the dominant presence of cold colors (figure 26).

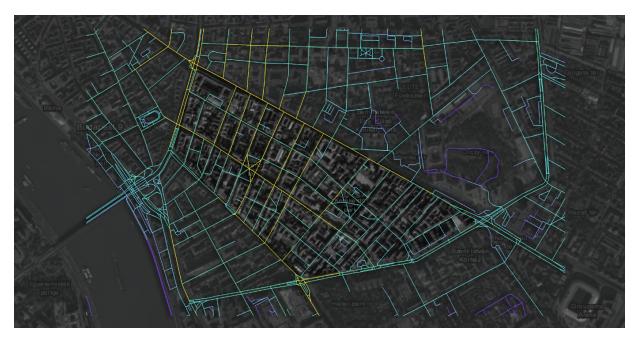
Figure 27*16***:** Global integration analysis of middle Ferencváros (2020) performd on DephtmapX. Source: by author

implementation of the urban renewal, dating from 2020. As indicated on the map (figure 27), several new pedestrian-only axes have been implemented, crossing the inner section of the urban blocks, represented by the color cyan. It represents not only a significant growth in quantitative terms of integration, but also meaning quality improvement, since all the designed new axes are part of the green infrastructure network implemented. The prominence of the longitudinal axes is further emphasized, as their significance has increased following urban restructuring along Tompa-Balázs Béla streets and Üllői Avenue. They are now indicated in warmer colors over a larger portion of their length (Fürstand, 2007).

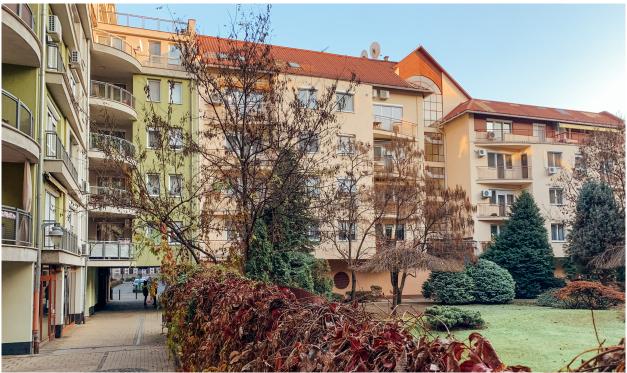
Figure 28: Pedestrian path segregated from the green courtyard by a planted hedge at IX District, Budapest (2021). Source: by author

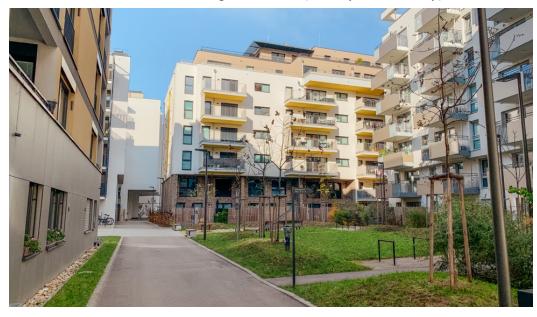
Figure 29*17***:** Newly reconstructed urban block - public pedestrian paths in the green shared courtyards, Vienna (2021). Source: by author

connecting axis between the center of the neighborhood and the riverside of the Danube River. The rest of the public areas are distributed among the courtyards generated by the layout in which the buildings are implanted, functioning as green areas for leisure and contemplation designed for pedestrians, with no access for cars. Although the system of courtyards is based on the traditional typology of traditional buildings in the city, in this context, the areas are not enclosed, being interconnected with each other and with public roads (directly or indirectly).

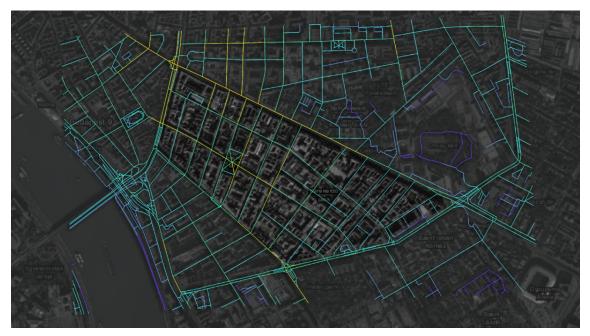
Figure 3018: Global integration analysis of IX District of Budapest (1990); performed on DephtmapX. Source: by author

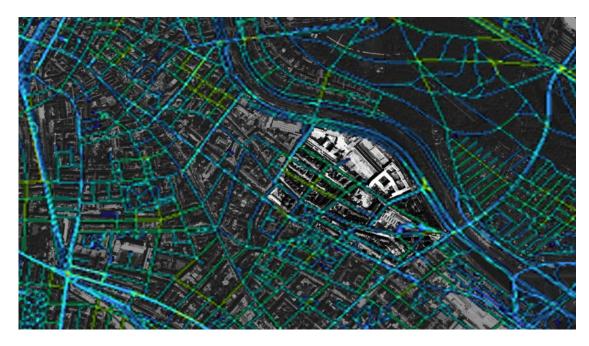
Figure 3119: Global integration analysis of III District of Vienna (1990); performed on DephtmapX. Source: by author

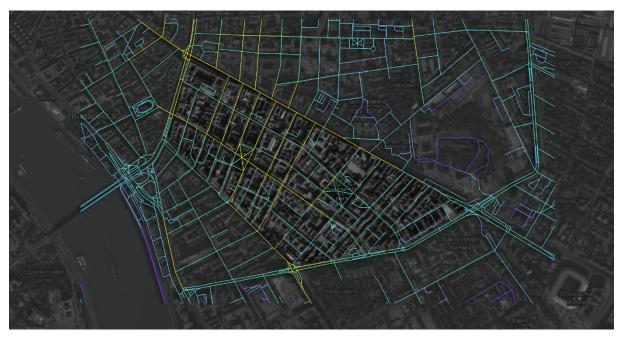
Figure 3220: Global integration analysis of IX District of Budapest (2020); performed on DephtmapX. Source: by author

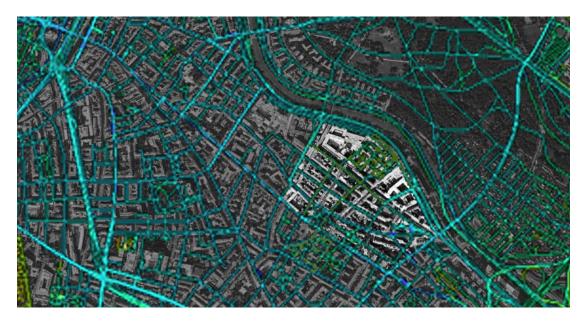
Figure 3321: Global integration analysis of III District of Vienna (2020); performed on DephtmapX. Source: by author

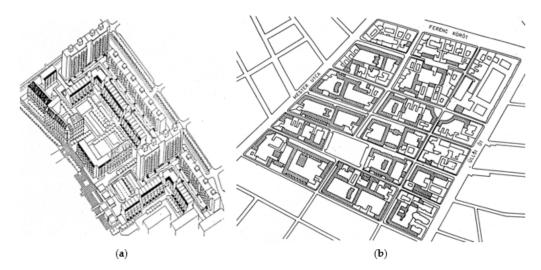
Figure 3422: Middle Ferencváros. (a) Scheme of a requalification plan from the late 1970s. Most of the historical buildings were set to be demolished and replaced by large prefab residential blocks

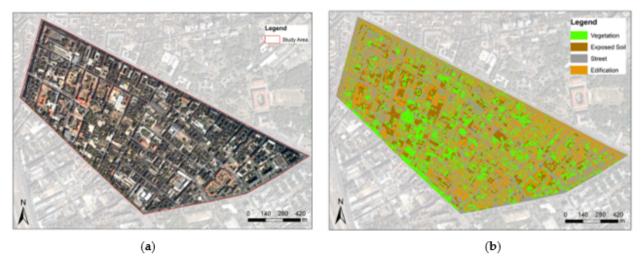
Figure 3623: Ferenceváros supervised classification. (a) Satellite image from the 2000s. It is possible to notice that most buildings have typological characteristics common to historic structures, which reverberate in the dense urban condition, despite the existent industrial voids.; (b) The supervised classification reveals urban fragmentation and the deficiency of green infrastructure in the area. Source: by author.

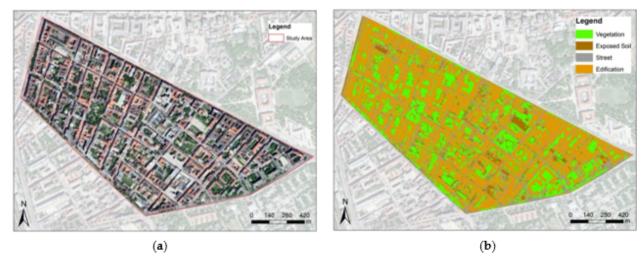
Figure 3825: Consolidation of the greenspace system. (a) Satellite image of 2021. Based on the morphological analysis, it is clear that the intervention has reached its stage of maturity; (b) implementation of green infrastructure is almost complete, and there are few areas marked as exposed soil. Source: by author.

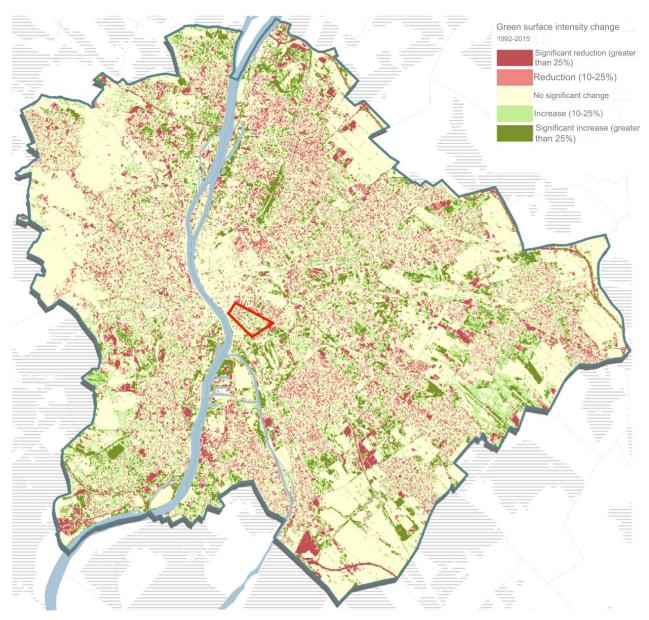
Figure 39: Budapest's change in green surface intensity from 1992 to 2015, with Middle-Ferencváros outlined in red. Source: Budapest Municipality, 2017

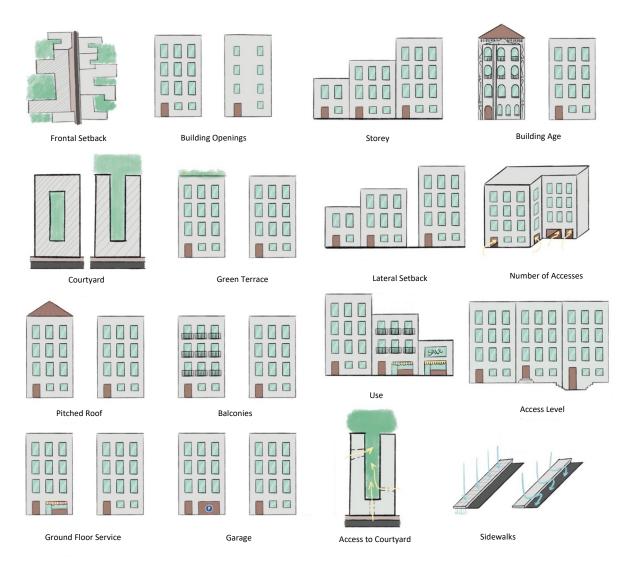
Figure 42: Icons created to facilitate visual identification by association in the research field. Source: by author.

To make the elements collected in Figure 41 more understandable for the focus groups, graphic icons were created. This approach aimed to reduce the probability of error in their judgments of the physical structure of the place. Some of the icons used can be seen in Figure 42.

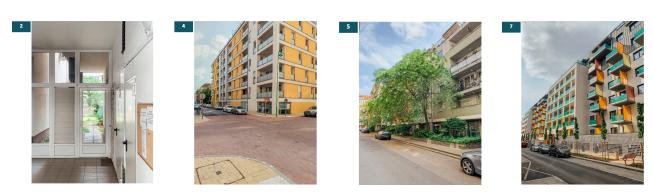
Figure 4427: Evaluation criteria of the typological survey linked to photos of the study area exemplifying the findings. Source: by author.

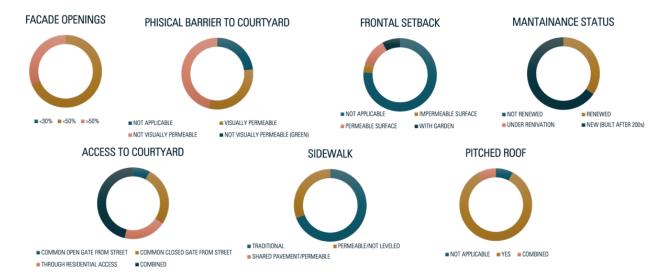
Figure 45: The graphs, derived from the data compilation, pertain to specific elements within the typological survey subgroups (refer to Figure 44). These highlighted elements exhibit some of the most distinct characteristics observed in the study area.

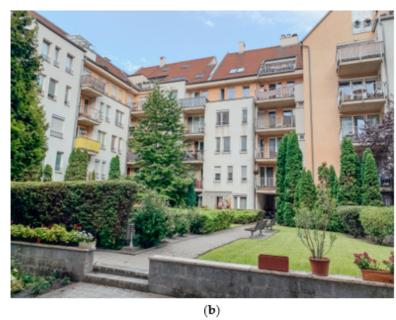
Figure 46: Residential buildings located on Lenhossék Street. (a) A juxtaposition of a renovated traditional historical building (T2) and a contemporary, newly constructed building (T1)—both entirely residential—defines a typical urban landscape in Frencváros. The noticeable distinctions in scale and constructive standards between the two buildings also add a dimension layer to the urban composition; (b) shared courtyard maintained by the residents of the newly built and renovated historic buildings. Source: by author.

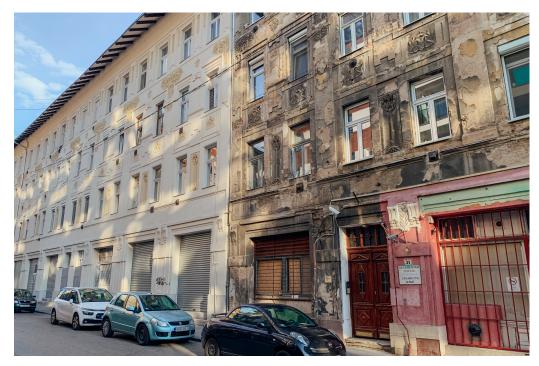
Figure 47: Buildings at Gát Street highlight the heterogeneous character of the area. The distinctions between the two mixed-use buildings within the same complex arise from their conservation status. The structure on the left side of the image has recently undergone renovation, whereas the one on the right awaits refurbishment. Source: by author.

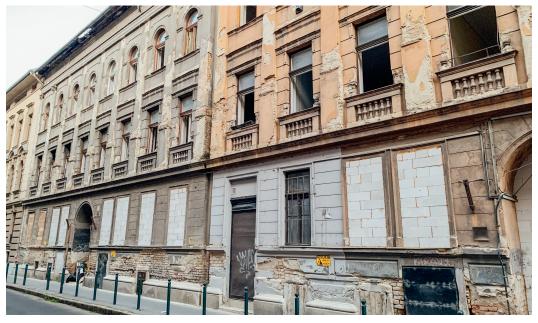
Figure 48: Structures at Viola Street vacated and isolated by the local municipality have languished for years, awaiting renovation efforts. Local residents were either compensated or relocated to alternative housing managed by the municipality while awaiting the completion of the construction works. However, this strategy intensifies challenges tied to urban gentrification, furthering the displacement of vulnerable populations to the city's outskirts. Source: by author.

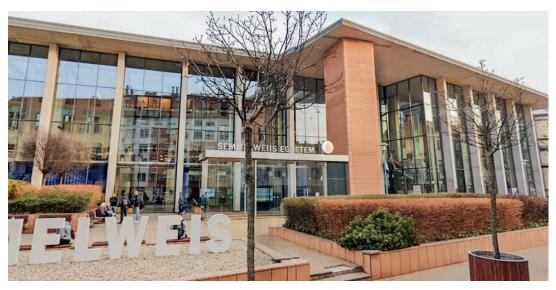
Figure 49: Contemporary aspect of the facade of the Semmelweis College building at Thaly Kálmán Street.

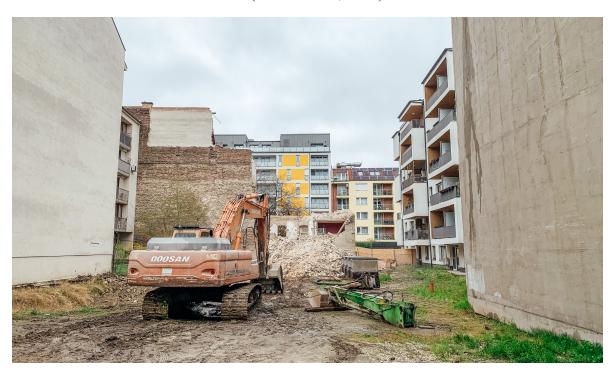
Figure 50: Urban void at Lenhossék Street, undergoing preparations for residential development scheduled to start in 2023. Source: by author.

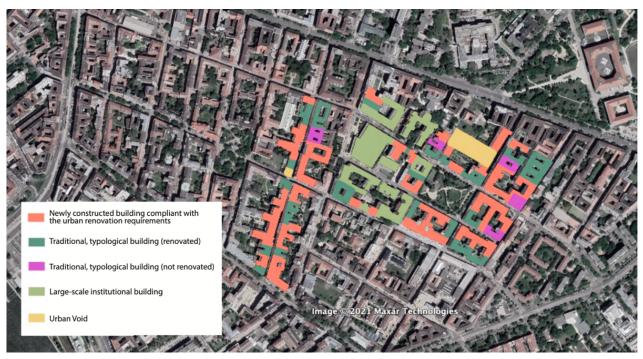
Figure 51: Buildings in the study area identified according to the categorization of typological subcomponents. Source: by author

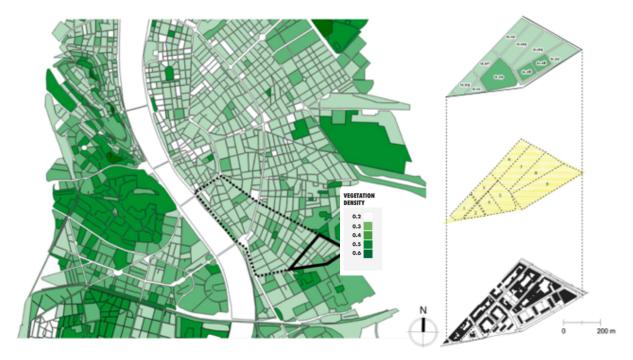
Figure 54: NDVI analysis highlighting the prevalence of green areas in renovated sections of Middle Ferencevians as well as in sections occupied by modern housing estates- Landsat 8 Satellite 2022.08.02. Source: outcome of the Urban Planning Workshop (MATE), 2023.

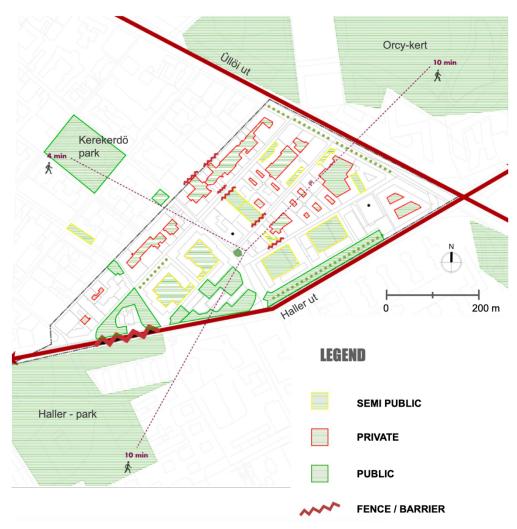
Figure 55: Accessibility analysis of green areas. Source: outcome of the Urban Planning Workshop (MATE).

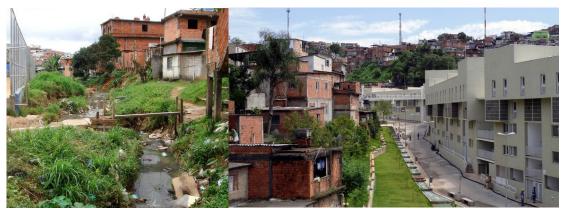
Figure A2: State of the local stream before and after the intervention. Source: Vigliecca & Associados, 2012

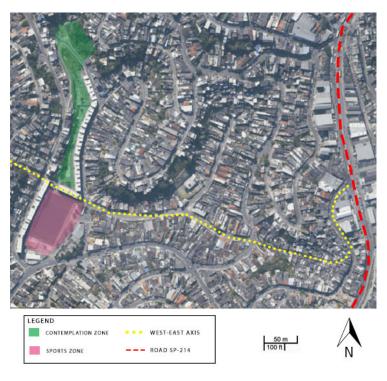
Figure A5: Parque Novo Santo Amaro V – zones of use and mobility axes. Source: by the Author

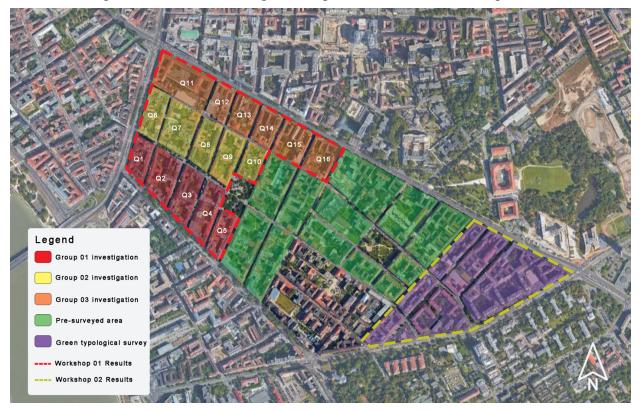
Figure A10: Urban Typological Survey administered in urban blocks Q1 to Q16. Source: by author.

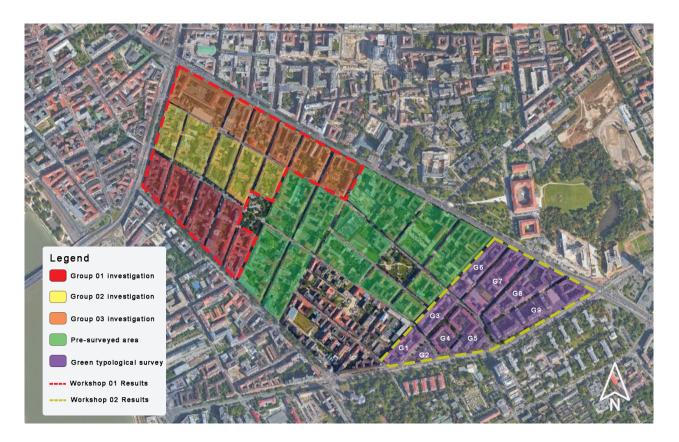
Figure A11: Urban Green Typological Survey administered in urban blocks G1 to G9. Source: by author.
